Upper Ragged Mountain Number 1,
Inventory Number: VA-00356. James River
Basin. Albermarle County, State of
Virginia. Phase I Inspection Report.

PHASE I INSPECTION REPORT NATIONAL DAM SAFETY PROGRAM

NAME OF DAM: UPPER RAGGED MOUNTAIN NO. 1

PHASE I INSPECTION REPORT
NATIONAL DAM SAFETY PROGRAM
NAME OF DAM: UPPER RAGGED MOUNTAIN NO. 1 ID# VA 00356

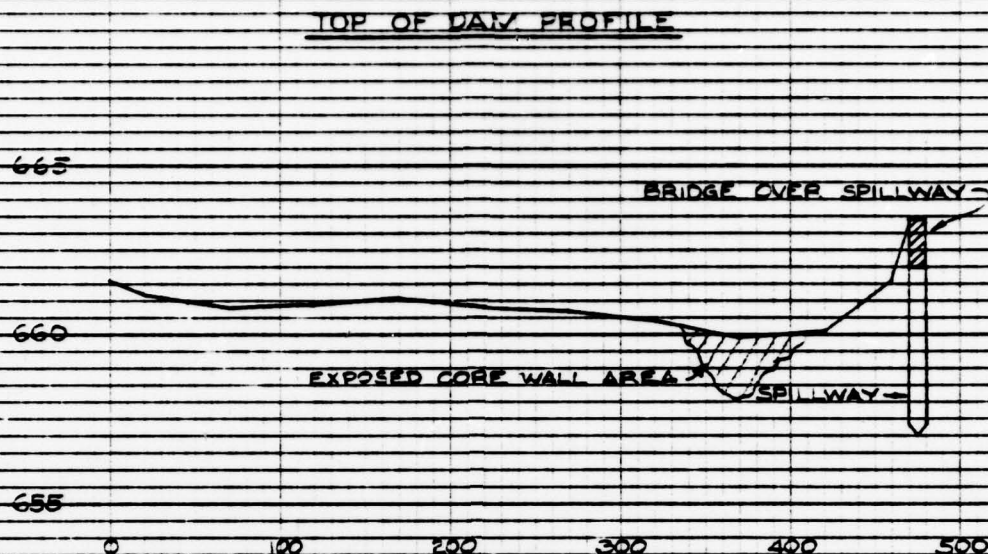
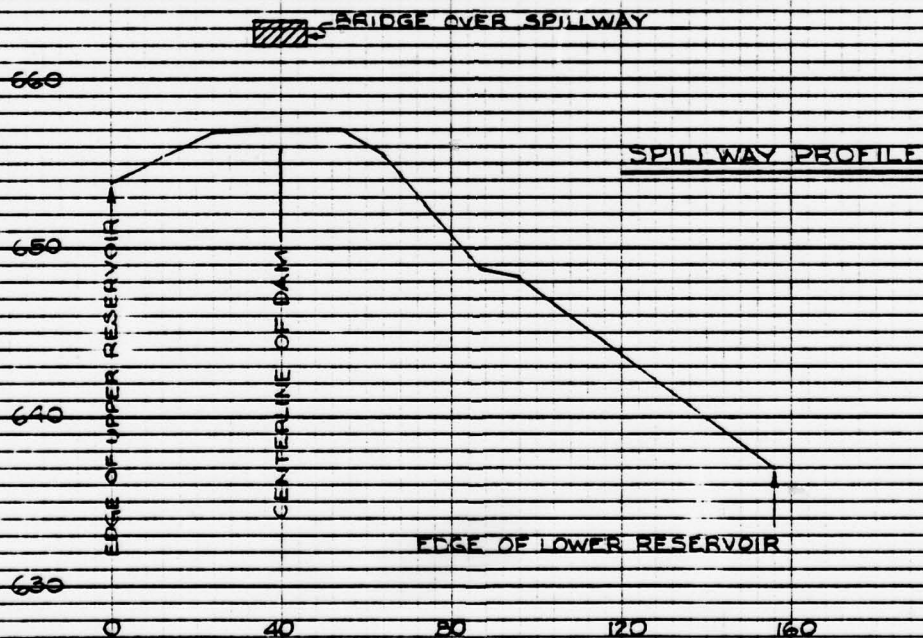
PLATE 3
UPPER RAGGED MTN. DAM NO. 1
MICHAEL BAKER, JR., INC.
SCALE: AS SHOWN

6.3 Evaluation: Since stability analyses were not available, a detailed stability assessment cannot be made. The clear seepage on the right side is in line with the low point of the dam (see Plate 3) where the earth has slumped or eroded from the downstream face of the stone core wall. The deficient conditions in this area may be related to an old slide. It is recommended that further field inspection be done in the right abutment area after the thick vegetation has been removed so that detailed remedial measures can be planned. It is suggested that test borings be drilled in the suspected slide area and piezometers be installed. The record of the boring or borings that had been drilled in the dam and any related data should be obtained if possible. A slope stability analysis should be performed on those sections of the embankment with the very steep toe using test results from the boring samples.

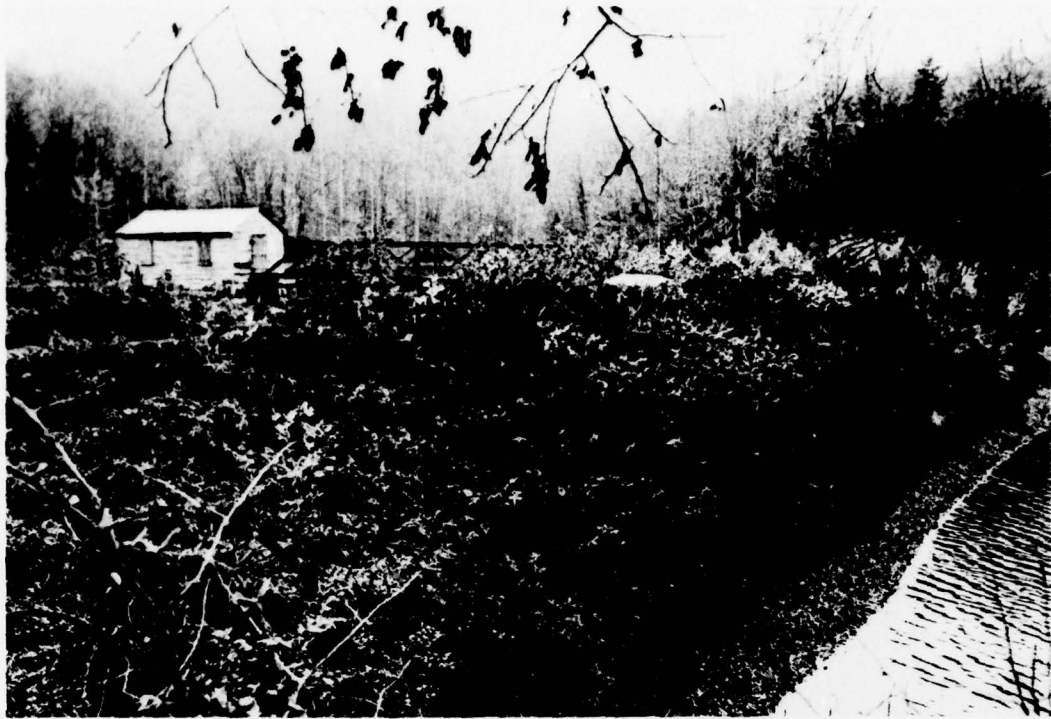
Photo 1. Outlet Works Downstream Embankment and Edge of Downstream Reservoir

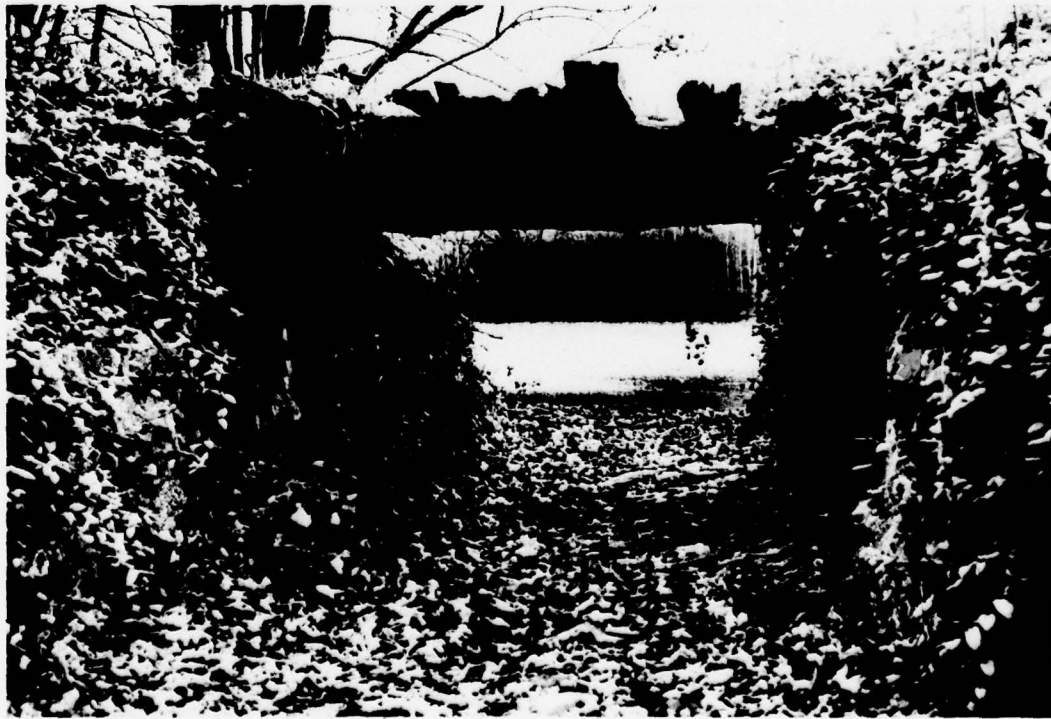
3.1.3 Open Channel Spillway: The stone masonry lined approach channel is in good condition. Some debris (branches and small logs) were piled along the spillway banks after removal from the channel by water authority personnel. This debris is a result of the beaver activity. The discharge channel is deeply incised in soil to weathered quartz monzonite. The discharge channel is uneven, and there are accumulations of wood debris and boulders in

PHOTO 2. Looking Upstream at Spillway in Right Abutment of Dam

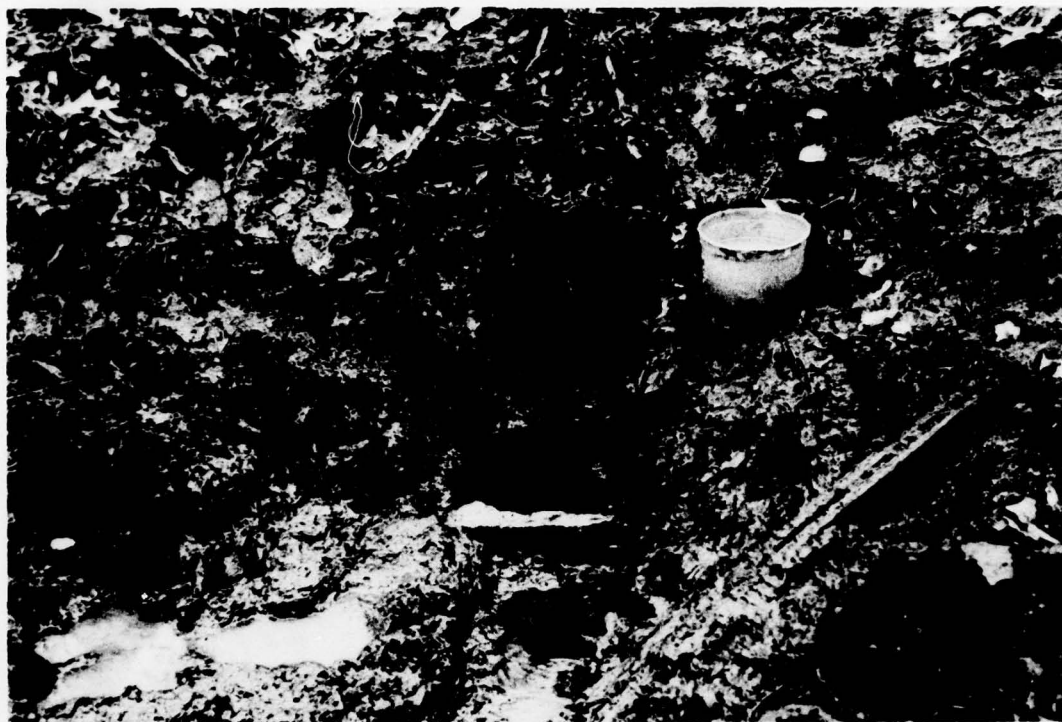
- 6.2.1 Visual Observations: The steep slope (1H:2V), which was measured by soundings only at one location at the downstream toe of the embankment, represents an undesirable condition. There is clear seepage (3 to 4 g.p.m.) on the downstream slope at the right abutment where erosion and sloughing have occurred. Minor seepage also occurs on the shore at the left abutment. Either slumping and/or erosion has exposed a portion of the stone core wall on the right side at the crest. The profile run of elevations along the crest of the dam (see Plate 3) shows a low area in the vicinity of the slump. Thick vegetation on the slopes of the dam hindered a thorough inspection of the surface conditions (see Photos 3, 4, and 5).

**PHOTO 5. Excavated Trench in Clear Seepage Area at Right Abutment
(Used to Determine Flow)**

Until further investigations can be conducted and remedial measures recommended and completed, the seepage areas should be monitored to watch for unstable conditions, especially when the reservoir is at higher pool levels.
